NASA Contractor Report 145326

Flight Service Evaluation of
Kevlar-49 Epoxy Composite
Panels in Wide-Bodied
Commercial Transport
Aircraft - Fourth Annual
Flight Service Report

LOCKHEED-CALIFORNIA COMPANY
BURBANK, CA 91520

April 1978

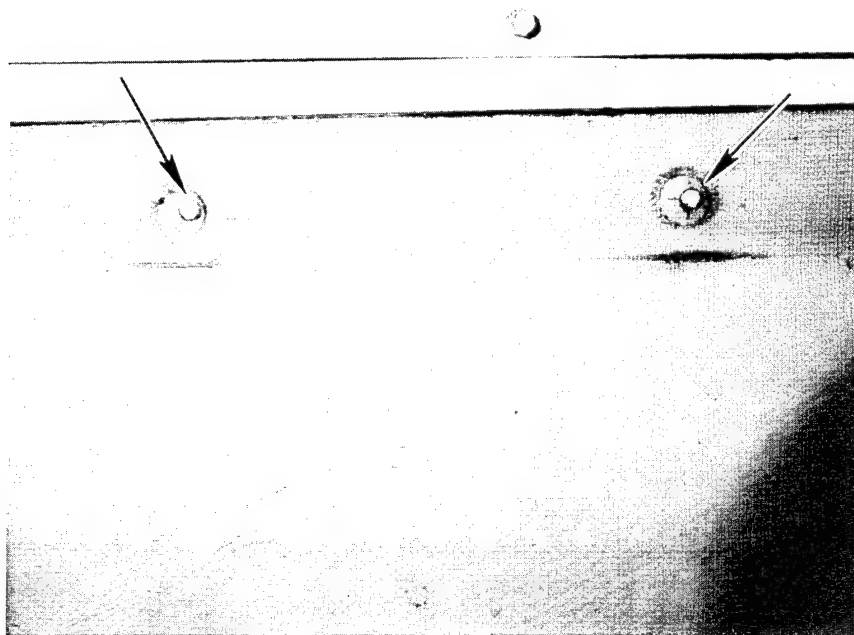
- 5) Slight fraying of the fastener holes was visible from the exterior on all four edges, with more fraying noted on the bottom edge. Heavier fraying was noted on three holes, one on the top edge and two on the aft edge. (Figure 12)

Figure 12. Eastern LH Wing-Body Fairing - Frayed Fastener Holes, Lower Aft Edge on Inner Surface

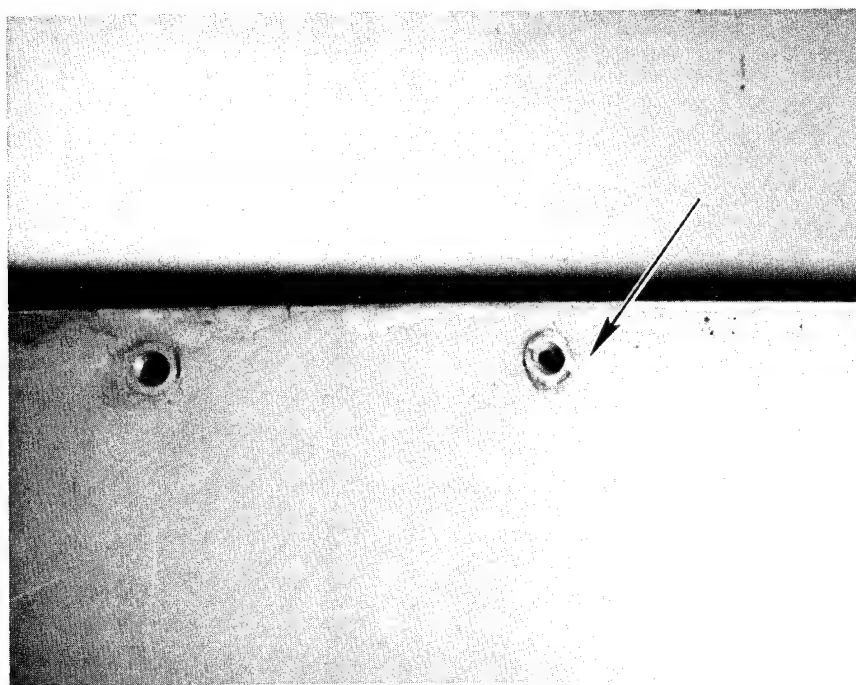
- 7) Considerable paint chipping and re-painting was noted around the fastener holes. (Figure 13)
- 8) No evidence of Skydrol contamination.

Figure 13. Eastern LH Wing-Body Fairing - Paint Loss Areas Around Fastener Holes, Exterior

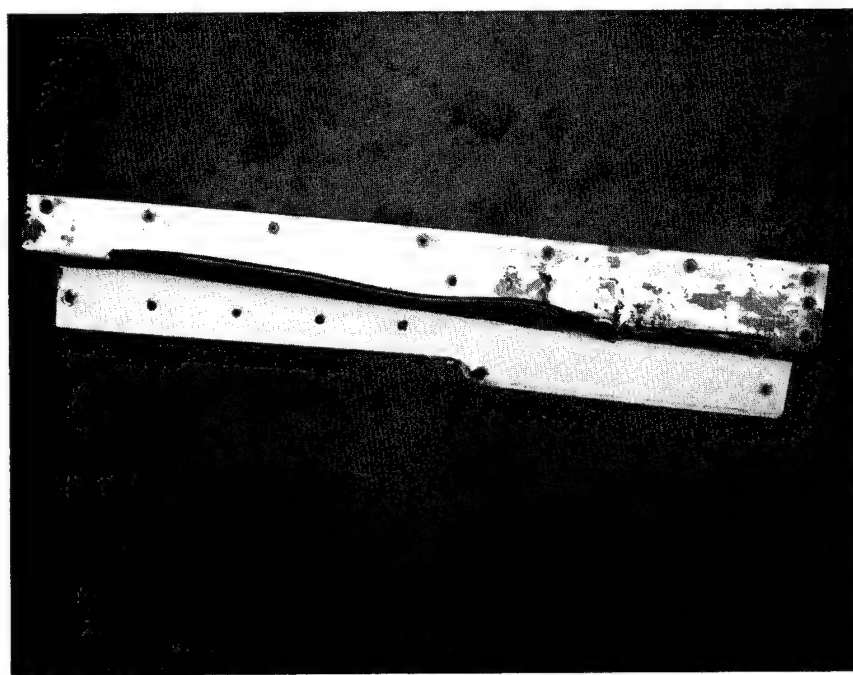
- 1) The panel weight was 1.02kg. (2 1/4 lbs.)
- 2) Paint is missing, with the Kevlar-49 surface exposed in extensive areas of the upper fillet. (Figure 14)
- 3) Fraying of fastener holes is visible from the exterior, but more noticeable viewed from the inner surface. Several elongated holes were noted which were the same ones observed in the 1975 inspection. No increase in elongation was noted. Fraying was more pronounced on the elongated holes. (Figures 15, 16, 17)
- 4) A slight gouged spot was noted on the upper forward area of the inner surface.

Figure 14. Eastern LH Underwing Fillet - Exterior Surface

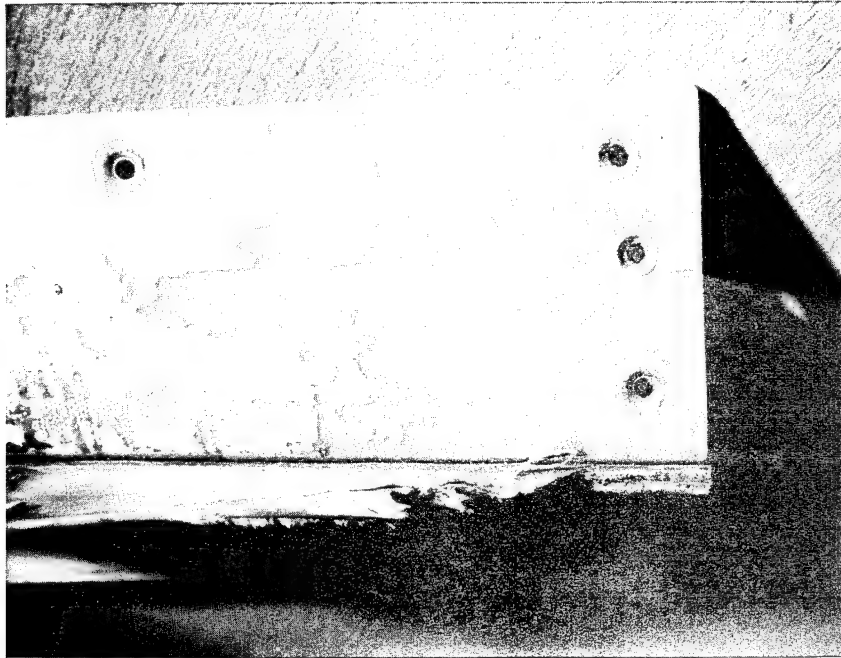
Figure 15. Eastern LH Underwing Fillet - Fastener Holes, Upper Aft Corner, from Exterior

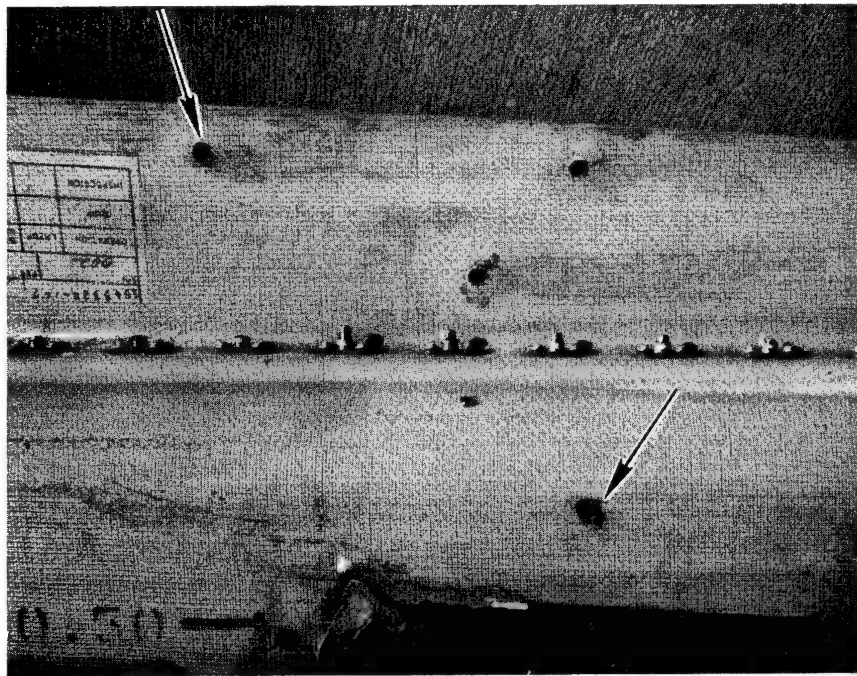
Figure 17. Eastern LH Underwing Fillet - Frayed Fastener Holes from Inner Surface

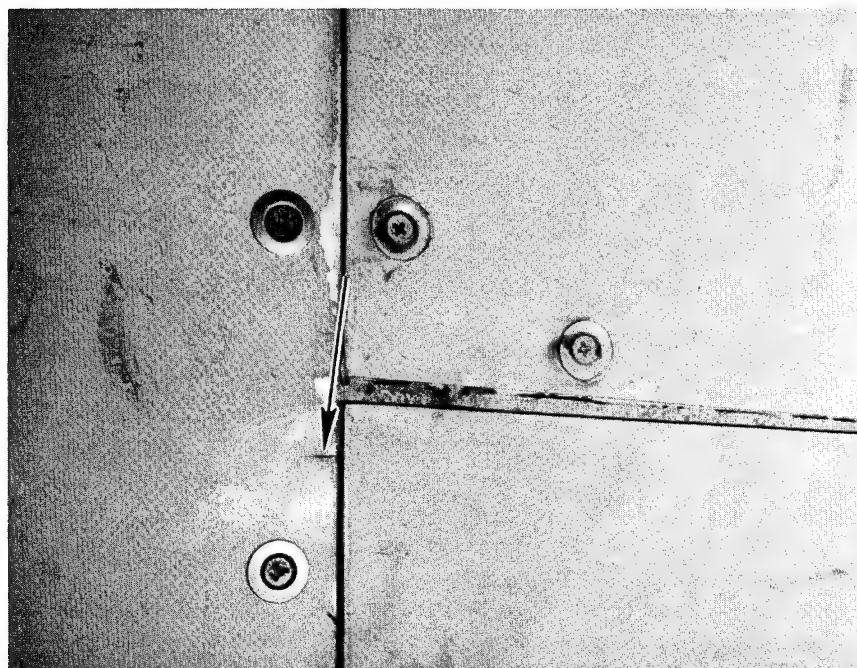
- 1) The following cracks observed in previous inspections were unchanged in appearance or extent:
 - 1.3 cm. (1/2 in.) crack at forward edge between 5th and 6th holes. No associated delamination. (Figure 18)
 - 0.6 cm. (1/4 in.) crack near exact center (may or may not be into skin) with scratch through paint to flame spray extending upward 20.3 cm. (8 in.). No delamination.
 - 0.3 cm. (1/8 in.) ding lower center - definitely into skin. No delamination.
 - 0.8 cm. (5/16 in.) crack in lower forward area - with slight associated delamination. 1.6 cm. (5/8 in.)
 - 0.3 cm. (1/8 in.) crack aft center - no associated delamination.

Figure 18. Eastern RH Wing-Body Fairing - Crack in Forward Edge 0.3 cm. (1/8 in.) Length

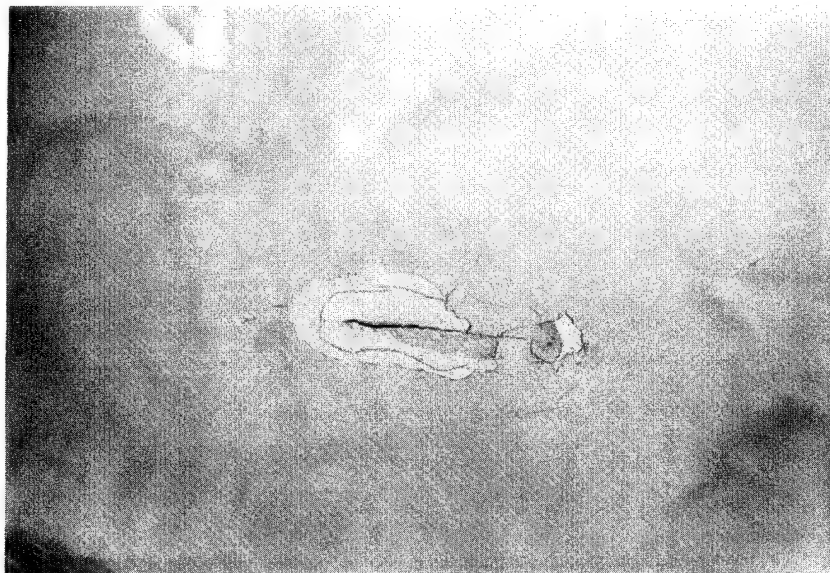
- 1) The panel weight was 697 kg (15 3/8 lbs.). Previous panel weight measured in 1976 was 672 kg (14.81 lbs.).
- 2) A 3.2 cm. (1 1/4 in.) crack was noted in the upper, aft area. (Figure 19). This crack has not grown or delaminated further since it was first observed in 1975. No other cracks were observed, and a 1.3 cm. (1/2 in.) crack observed in 1976 was apparently only in the original paint layer and had been repainted.

Figure 19. Air Canada LH Wing-Body Fairing - Crack, Exterior Surface, 3.2 cm (1-1/4 in.) Length

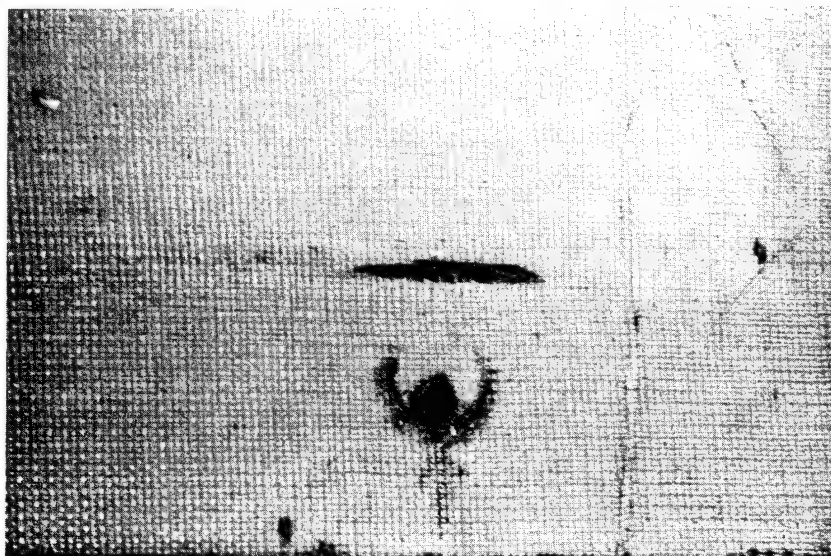
- 3) Fastener holes appeared slightly frayed as viewed from exterior and inner surfaces, with a greater degree of fraying noted on the bottom edge holes as viewed from the inner surface. (Figure 20). Slight hole elongation was observed on all fastener holes on the bottom edge, plus two other holes on the forward and top edges.

Figure 20. Air Canada LH Wing-Body Fairing - Close-Up of Fastener Holes on Bottom Edge, Inner Surface

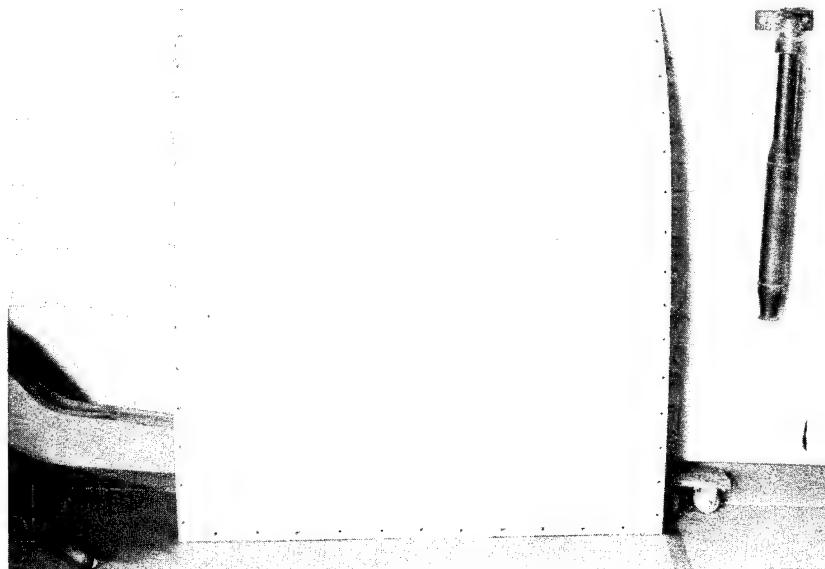
- 4) Extensive paint loss was observed on edges and upper forward area, but no associated damage in the part. (Figure 21).
- 5) No defects or damage were observed on the inner surface.

Figure 21. Air Canada LH Wing-Body Fairing - Exterior

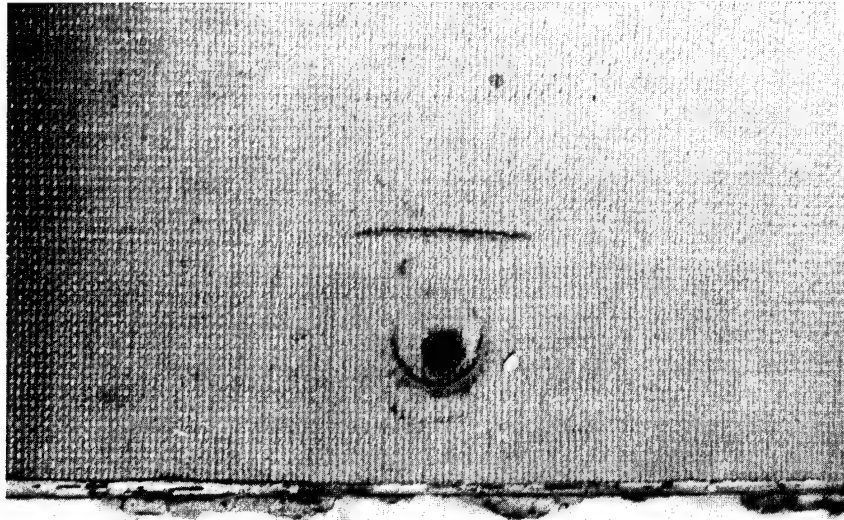
Figure 23. Air Canada RH Wing-Body Fairing - Close-Up of Fastener Holes, Bottom Edge, from Inner Surface

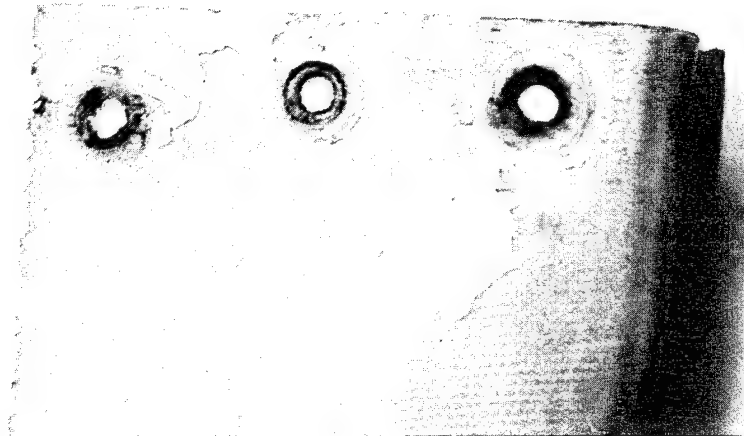
Figure 25. Air Canada LH Underwing Fillet - Fastener Holes, Upper Aft Area, from Exterior

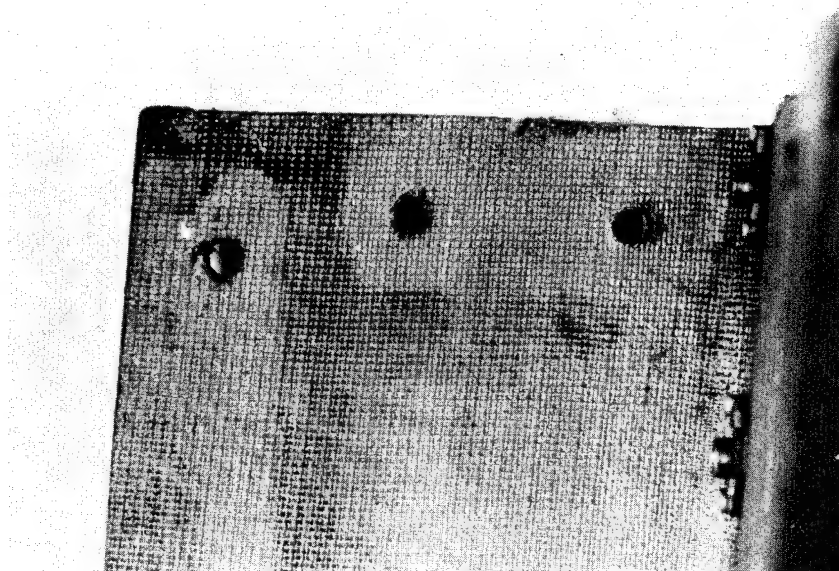
Figure 27. Air Canada RH Underwing Fillet - Fastener Holes, Upper Aft Area, from Inner Surface

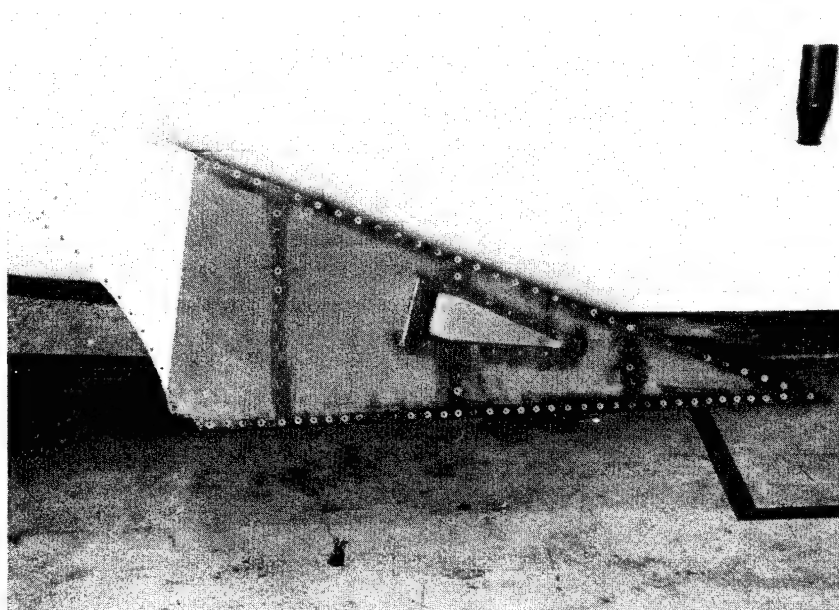
- 1) The panel weight was 2.89 kg (6 3/8 lb.).
- 2) No surface damage or defects were noted. (Figure 28).
- 3) Extensive fraying of fastener holes was observed on all edges as viewed from both surfaces. (Figure 29). Loose Kevlar-49 fibers were noted inside holes. The intercostal holes through the core area were more frayed than holes in the edge laminate. (Figure 30). Elongation was noted only to a very slight degree on three holes along the bottom edge.

Figure 28. Air Canada LH Aft Engine Fairing - Exterior Surface

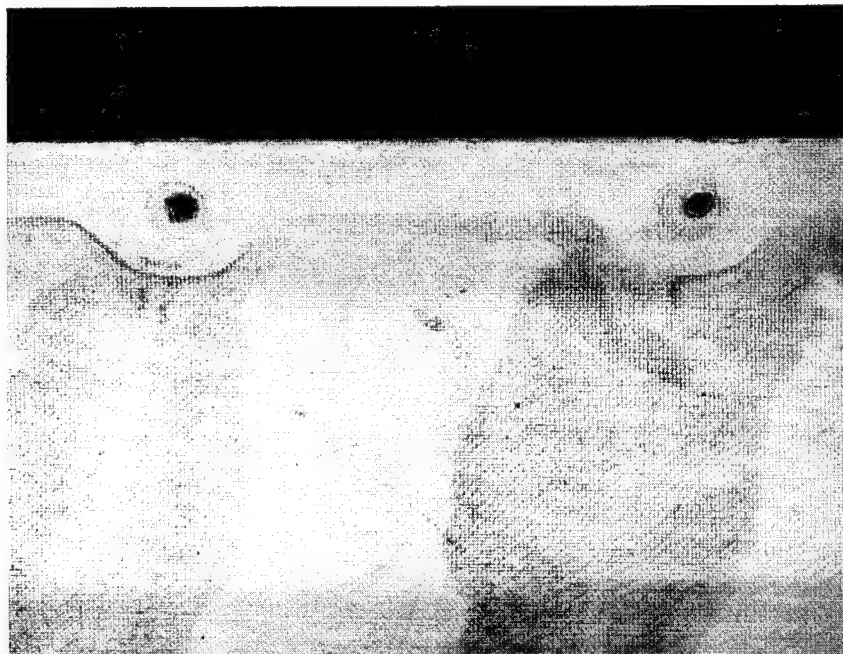
Figure 32. TWA LH Wing-Body Fairing - Typical Fastener Holes Viewed from Inner Surface

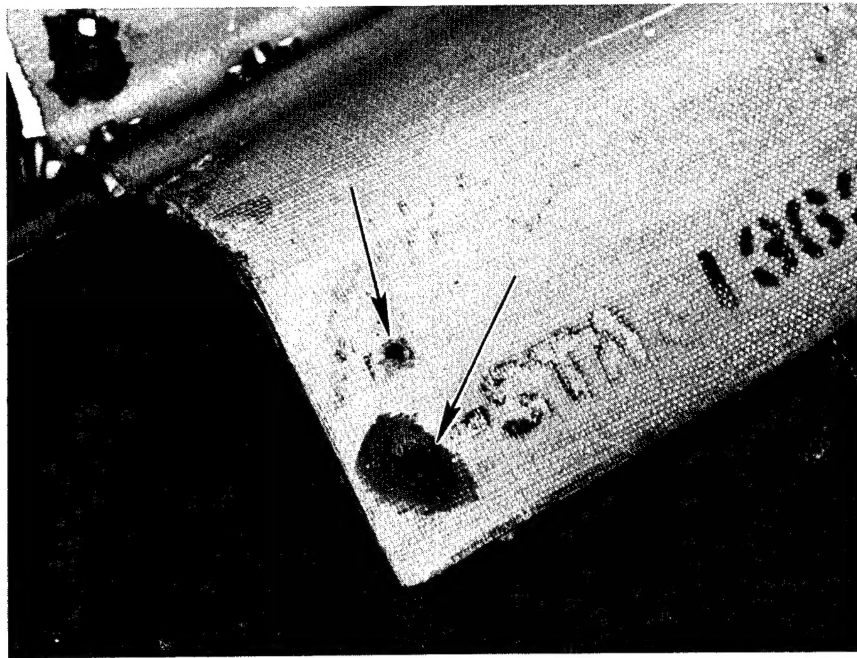
Figure 35. TWA LH Underwing Fillet - Filled and Relocated Fastener Holes

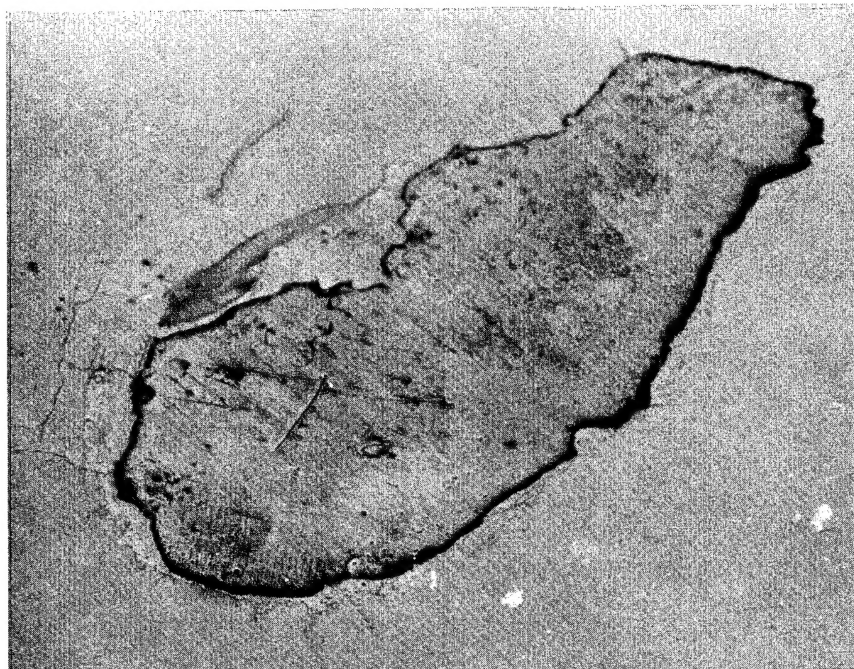
Figure 36. TWA RH Aft Engine Fairing - Repainted Area with Possible Skin Damage

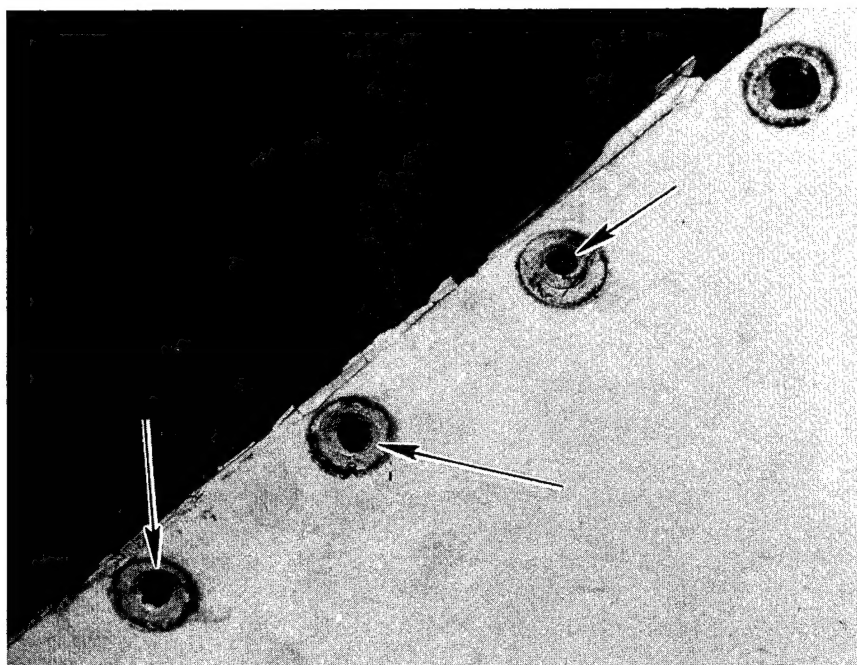
In one instance, hole deformation has been observed on parts other than the underwing fillets, and these are the TWA aft engine fairings. These fairings, as described in the Second Annual Report (Ref. 3), required relocation of all fastener holes during reinstallation. The holes were filled with a chopped glass filled epoxy, and a layer of epoxy impregnated 120 glass cloth was applied to both surfaces. Many holes were redrilled through the filled area, and these holes show a significantly greater degree of elongation than any holes drilled through a solid Kevlar-49 laminate. This condition, while not affecting part performance or requiring corrective maintenance, does indicate an inadequacy of the repair; and does not reflect on the performance of Kevlar-49.

Figure 39. TWA RH Aft Engine Fairing - Fastener Holes Viewed from Exterior, Showing Elongation

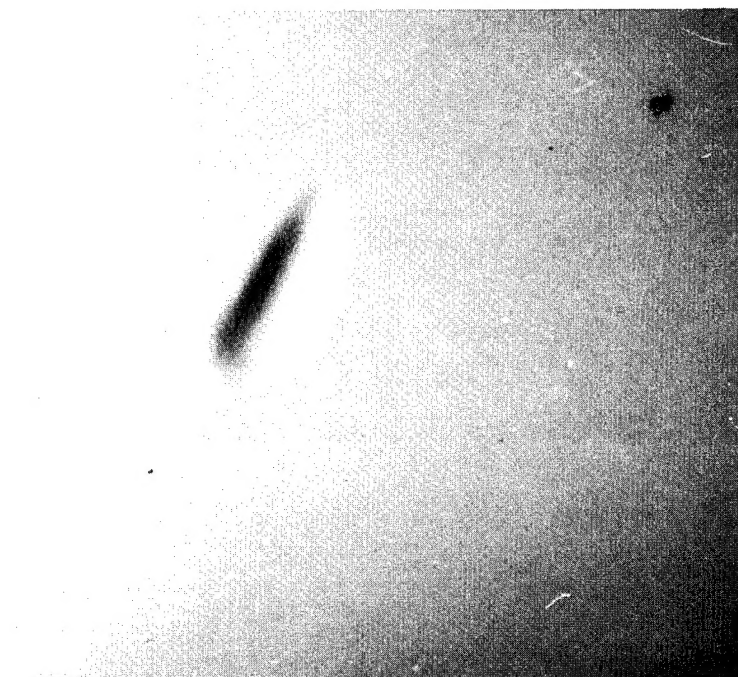
A more extensive damage condition was observed on the TWA right-hand wing-body fairing. This is a fairly deep concave depression and skin-core disbond, but with no associated crack or surface damage, which does not appear to be the result of impact damage. This condition is probably related to a repair made in this part during its reinstallation on Ship 1111 (Ref. 3). This repair was not documented, but apparently consisted of replacement of a damaged core area, extending partially through the core thickness, with a microballoon filled potting compound. Crushing of this potting compound under in-service conditions is a possible explanation of this condition. In any case, this does not appear to be a Kevlar-49 related problem, but as it is highly visible it will be carefully monitored in future inspections.

Figure 40. TWA RH Wing-Body Fairing - Concave Depression with Disbond, Exterior Surface

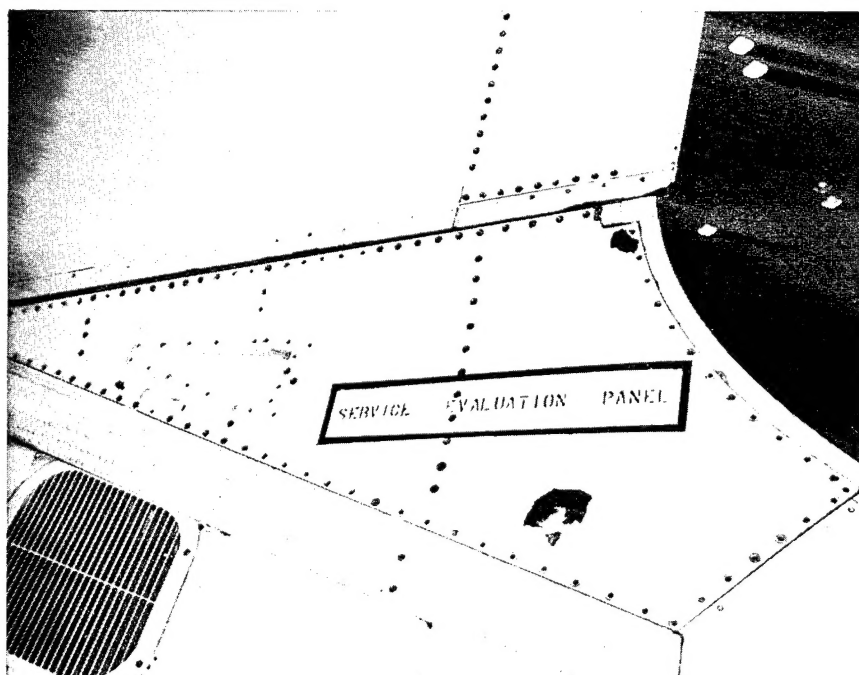
Figure 42. TWA LH Aft Engine Fairing - Exterior Surface on Aircraft Showing Paint Loss Areas
